Risk Assessment of Buildings due to Lightning Impulses: A Case Study at College of Science and Technology

Namgay Tenzin

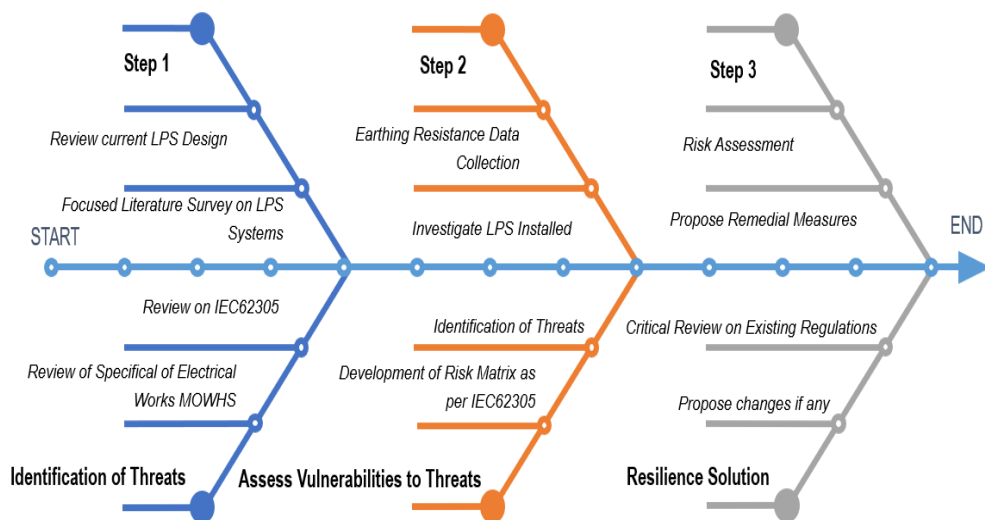
Fig 2. Schematic Methodology Used for Study.

The study was implemented in three steps: 1) Review on the current Lightning Protection System Design and Relevant Standards, the LPS design methods, and existing guidelines. The threats to the building were then identified and risk score was being assigned according to IEC standard IEC 62305-2 Protection against lightning. 2) Risk management (International Electrotechnical Commission., 2010a) followed by data collection on earthing resistance, LPS system installed in the CST campus and development of risk matrix. 3) Risk assessment due to lightning impulse as per IEC62305-2 and proposed remedial measures. The study also reviewed the existing regulations and made critical comments. Figure 2 illustrates the methodology used for the study.

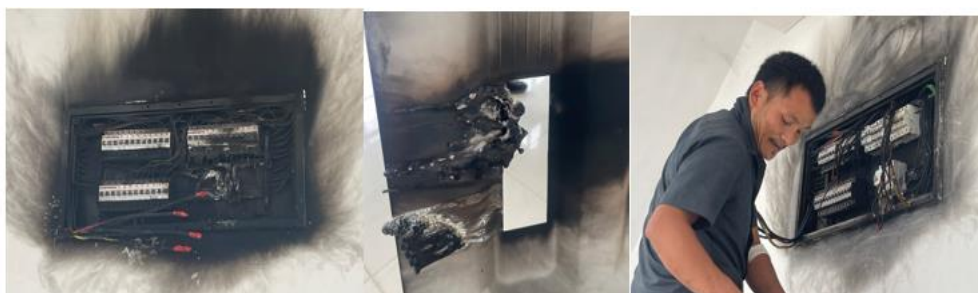
Fig 5. SMDB Burned due to Lightning Impulse.

The study focused on the impact of lightning on the buildings. Therefore, residential units, academic blocks and student hostel areas were included in this research. From the preliminary data collection, it was observed that at CST, network switches were frequently damaged by the lightning, where a total of 22 network switches were damaged in 2019-2021. The location of the damaged switches is depicted in Figure 3. A surge protective device installed on a rooftop solar photovoltaic system on the roof of library building was also destroyed in 2019 which is shown in Figure 4. In June 2022, a sub main distribution board was damaged and control gear (RCCB) was burned beyond recognition due to lightning impulse, which is shown in Figure 5.

It was observed that, at numerous locations including Staff Quarter B, Lightning Arrestor (LA) is not fixed properly, at Academic Block, LA is missing down conductors, and similar incidents are observed throughout the CST campus. In order to safely discharge the energy content in lightning impulse standards; IEC 62305 and IS 3043; specification of electrical works by DES, MoWHS, the recommended ground or earth resistance should be lower than 5Ω . This is not present at all the measurement sites as per the earth resistance data presented in Figure 5. This might be one of the main causes of the accidents related to the lightning impulses.

Building electrical installations are critical components and design of installation with adequate control and protection is important. It was observed that in SMDBs there were no TPN MCBs, which is one of the important protection gears for secondary isolation of the circuits and also MCCB lever which is spring controlled needs to be charged and discharged to operate systematically.

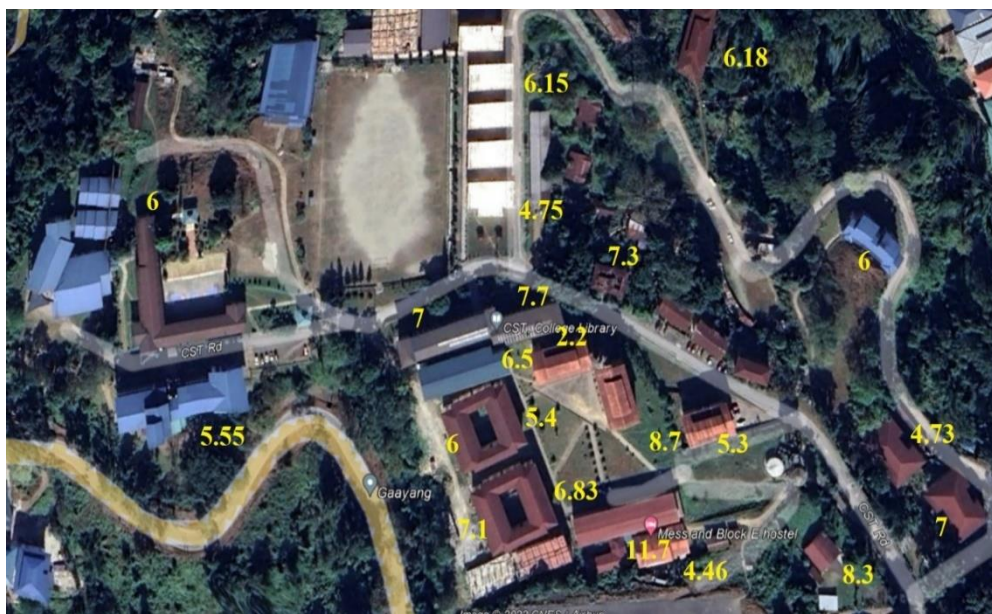
Fig 6. Earth Resistance Value (in Ohms) of Different Buildings at CST.

The earth resistance was surveyed using four pin Weener Method and 3 pin fall of potential method. Figure 6 describes the earth resistance of various buildings in CST campus. The measurements were noted in October 2021.

The overall earth resistance profile of campus is not as per standard and required guidelines. Moreover, an important electrical installations like network switches for ICT services should be protected with surge protective devices which will shield an indirect and secondary lightning wave. Along with it, the earth resistance should be within the permissible limit or lower to provide an alternate path for high energy content lightning impulse to discharge to the ground.

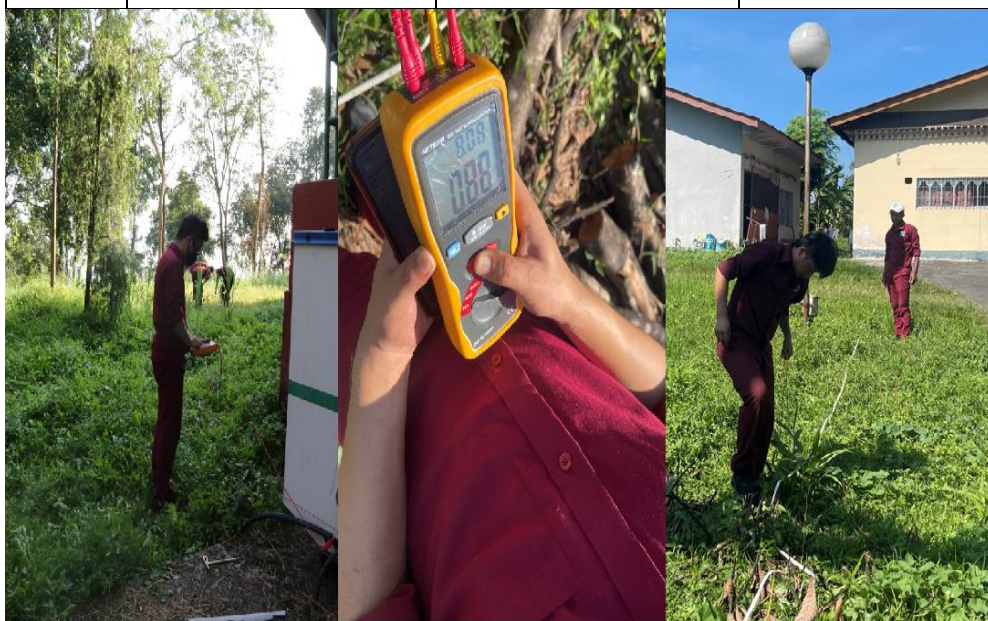
Fig 7. Measurement of Earth Resistance.

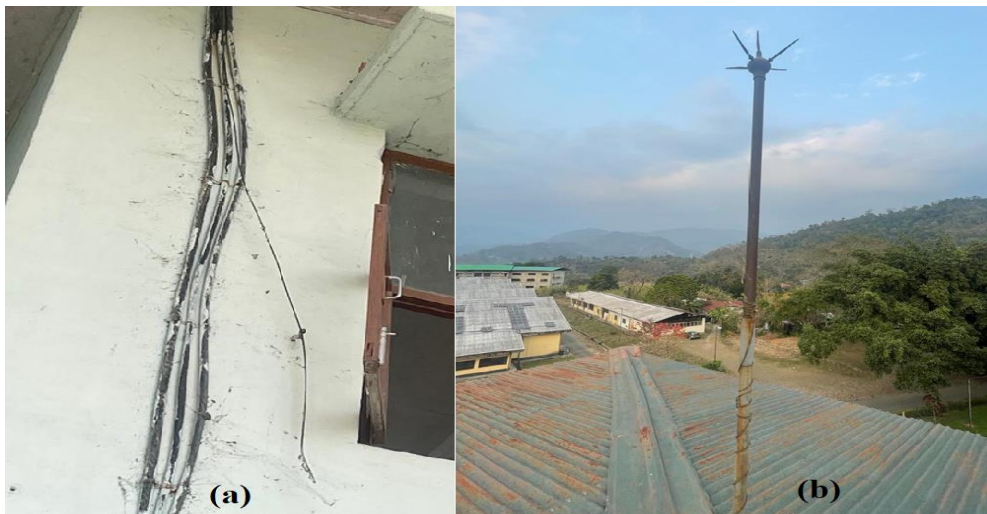
In most of the buildings the air termination units in the form of lightning arrestors are being installed but many does not have down conductors, thereby, rendering the LA useless (Fig.8). The buildings under study had LAs installed except for IT building and RK building. Some observations made during the field survey were incorrect operation of control gears. It was observed that in the main distribution board of Administrative Building where SMDB was damaged, the Molded Case Circuit Breaker (MCCB) lever was not discharged properly, meaning the lever was in the middle which meant that the circuit was not interrupted. This might have resulted in continuous flow of current in the circuit. It was also observed that the SMDBs in that very building lacked TPN MCBs for secondary isolation. Generally, each SMDB is controlled by TPN MCB and RCCB.

Fig 8. (a) Missing Down Conductors. (b). LA installed.

The student hostel blocks A and D have LAs installed but down conductors are missing and in RK building there are no LAs being installed. Analyzing the height of different structure nearby, it was observed that RK building was tallest structure in the area. So, there is high probability that lightning would first strike the roof structure of the RK building. Hence, our study necessitates the installation of air termination lightning arrestors in both wings of RK hostels. Similarly, in IT building too, LAs are missing because IT building occupies a sufficient area and there are no tall structures nearby. Due to this, LAs are required in IT building premises.
